MECHANISMS AND REMEDIATION
OF CUT BATTER FAILURES ALONG THE QUEENS ROAD AT
WAINIGASAU AND NAMUKA I LAU, VITI LEVU, FIJI
ISLANDS.

A THESIS SUBMITTED IN PARTIAL FULFILMENT OF THE REQUIREMENTS FOR

MASTER OF SCIENCE IN ENGINEERING GEOLOGY

UNIVERSITY OF CANTERBURY

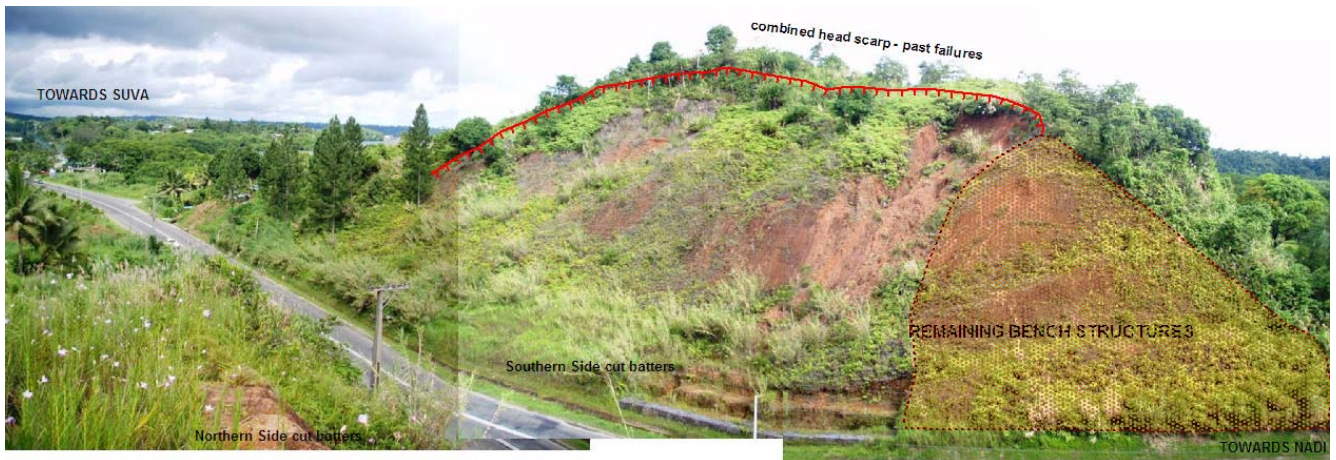
cut batter resulting in a large scarp feature that has joined the head scarps of the past failures (see Figure 3.7).

Figure 3.7 Namuka i lau southern bench structures destroyed except for 25 metres on western end of cut batter

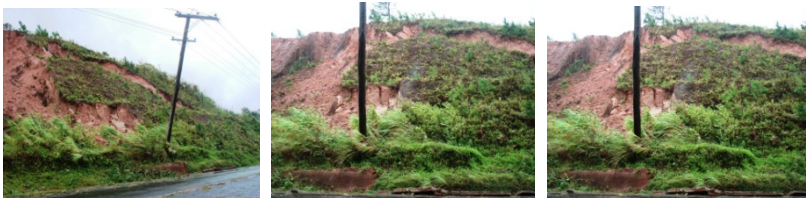
Failure migrating laterally to eastern limit and retrogressing to 3 rd bench
May 2008

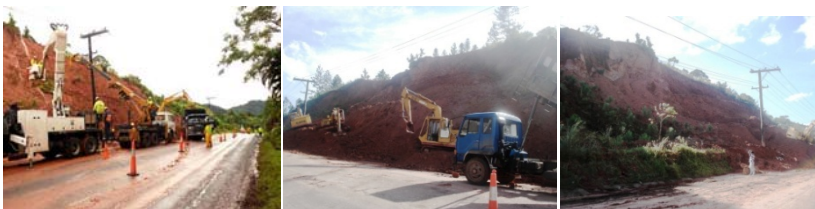
Subsequent failure leading to reconstruction of cut batters into 3 benches at 60 degree slopes
September 2008

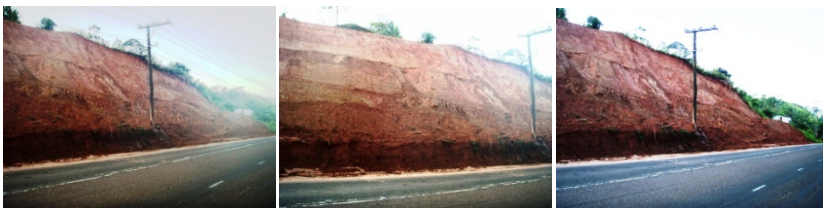
Failure of reconstructed benches 1 and 2
August 2009

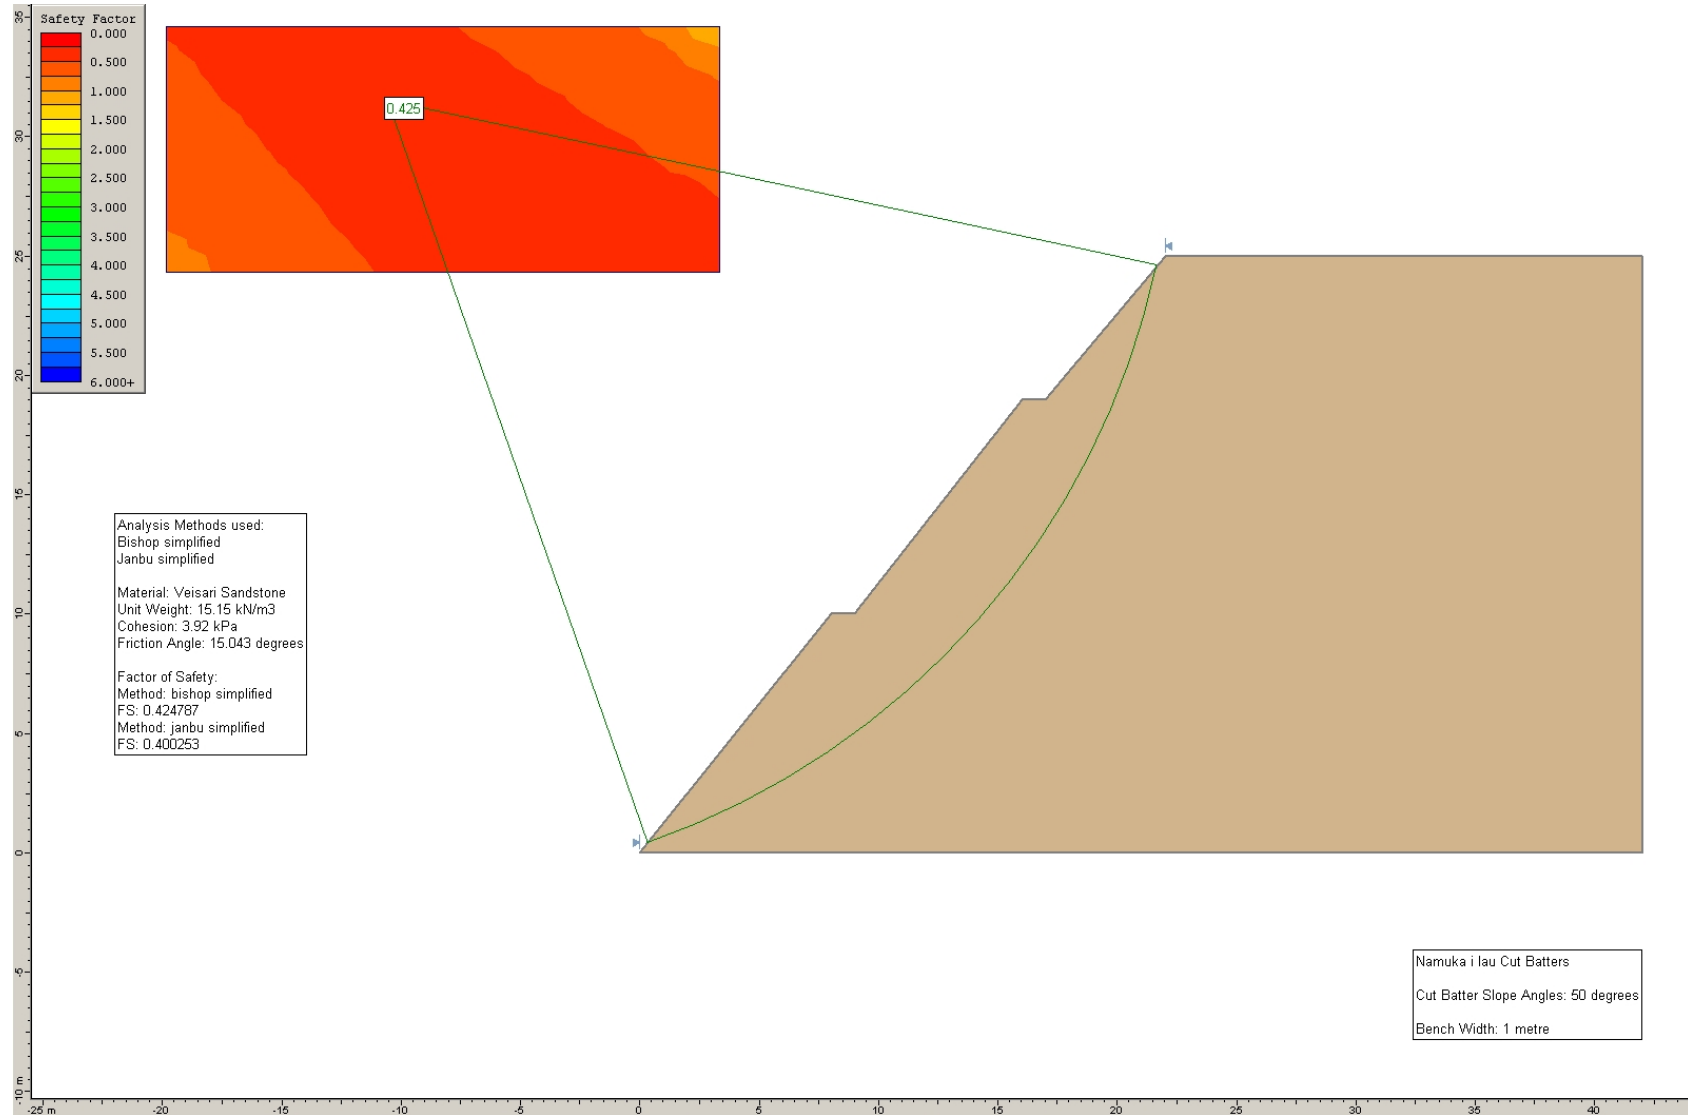
$$FS = 0.420$$

Figure 5.2 Slide analysis of Namuka I lau cut batter using Bishop Simplified Method

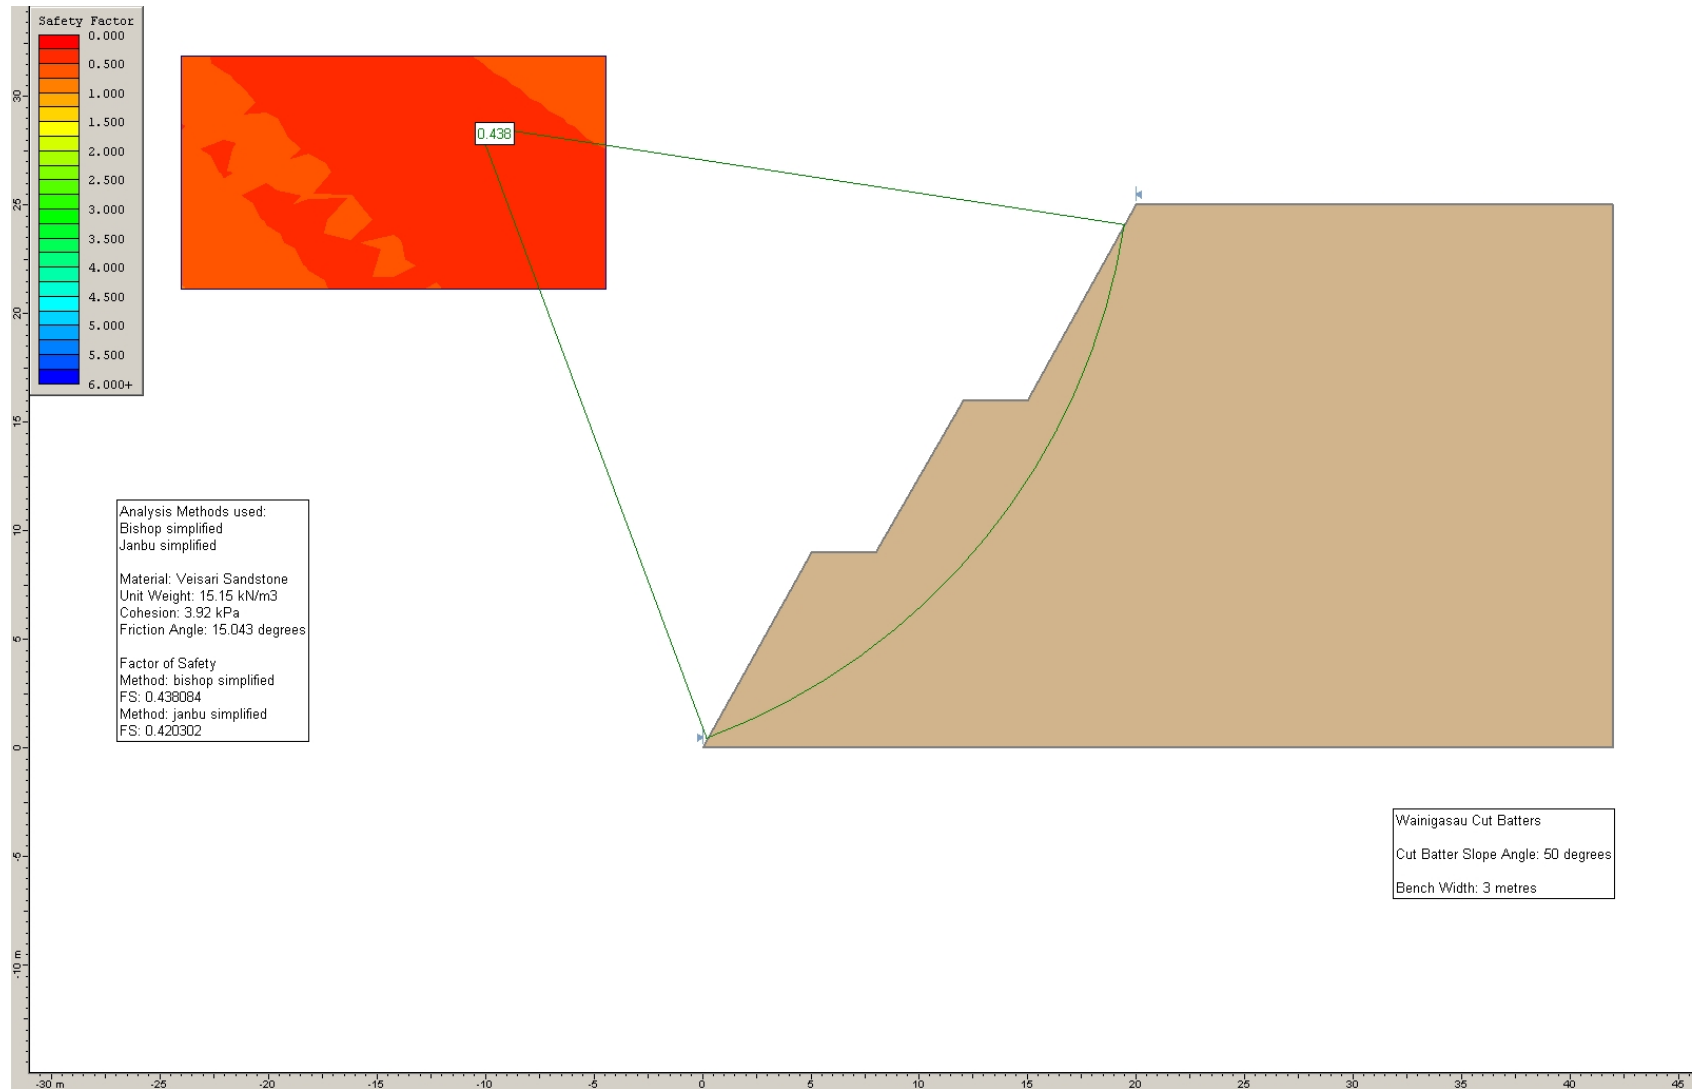
Figure 5.3 Slide analysis of Wainigasau cut batter using Bishop Simplified Method

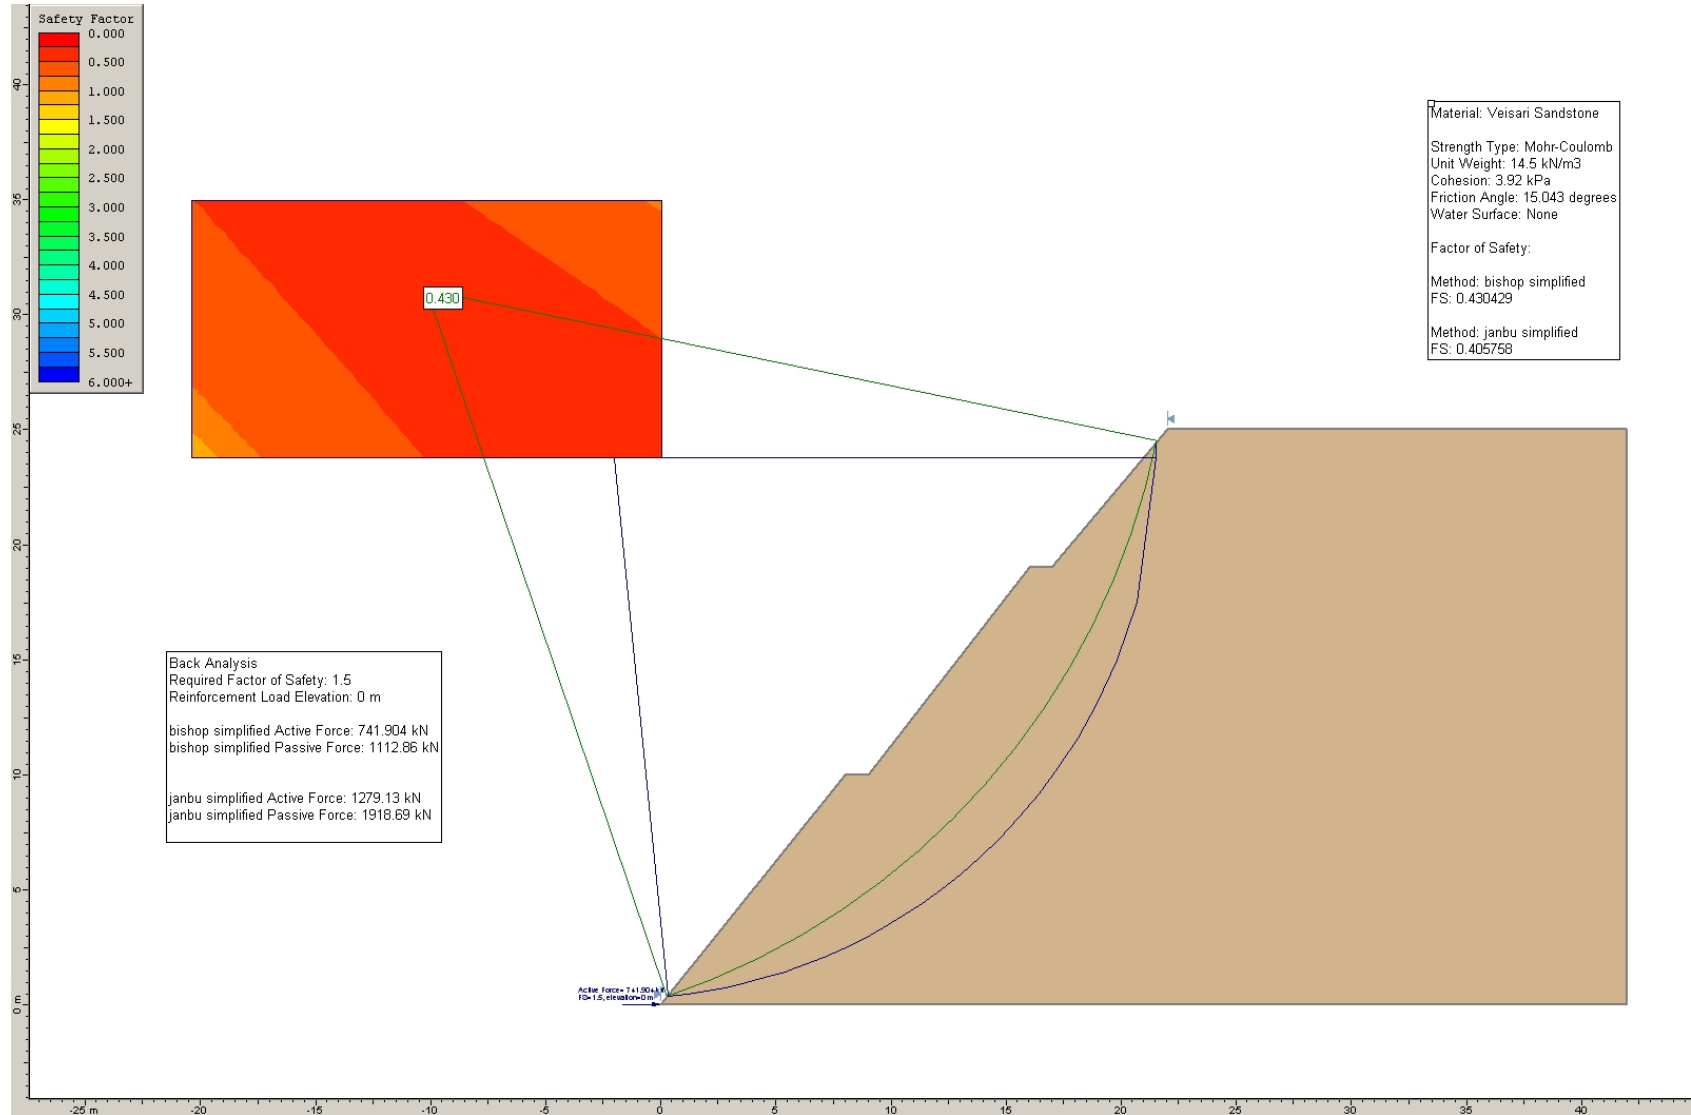
Figure 5.4 Back analysis using SLIDE for Namuka I lau cut batters

calculated is the amount needed to be removed from the driving forces to achieve a factor of safety of 1.5. This can be achieved at the Namuka i lau and Wainigasau sites through unloading by flattening of the slopes.

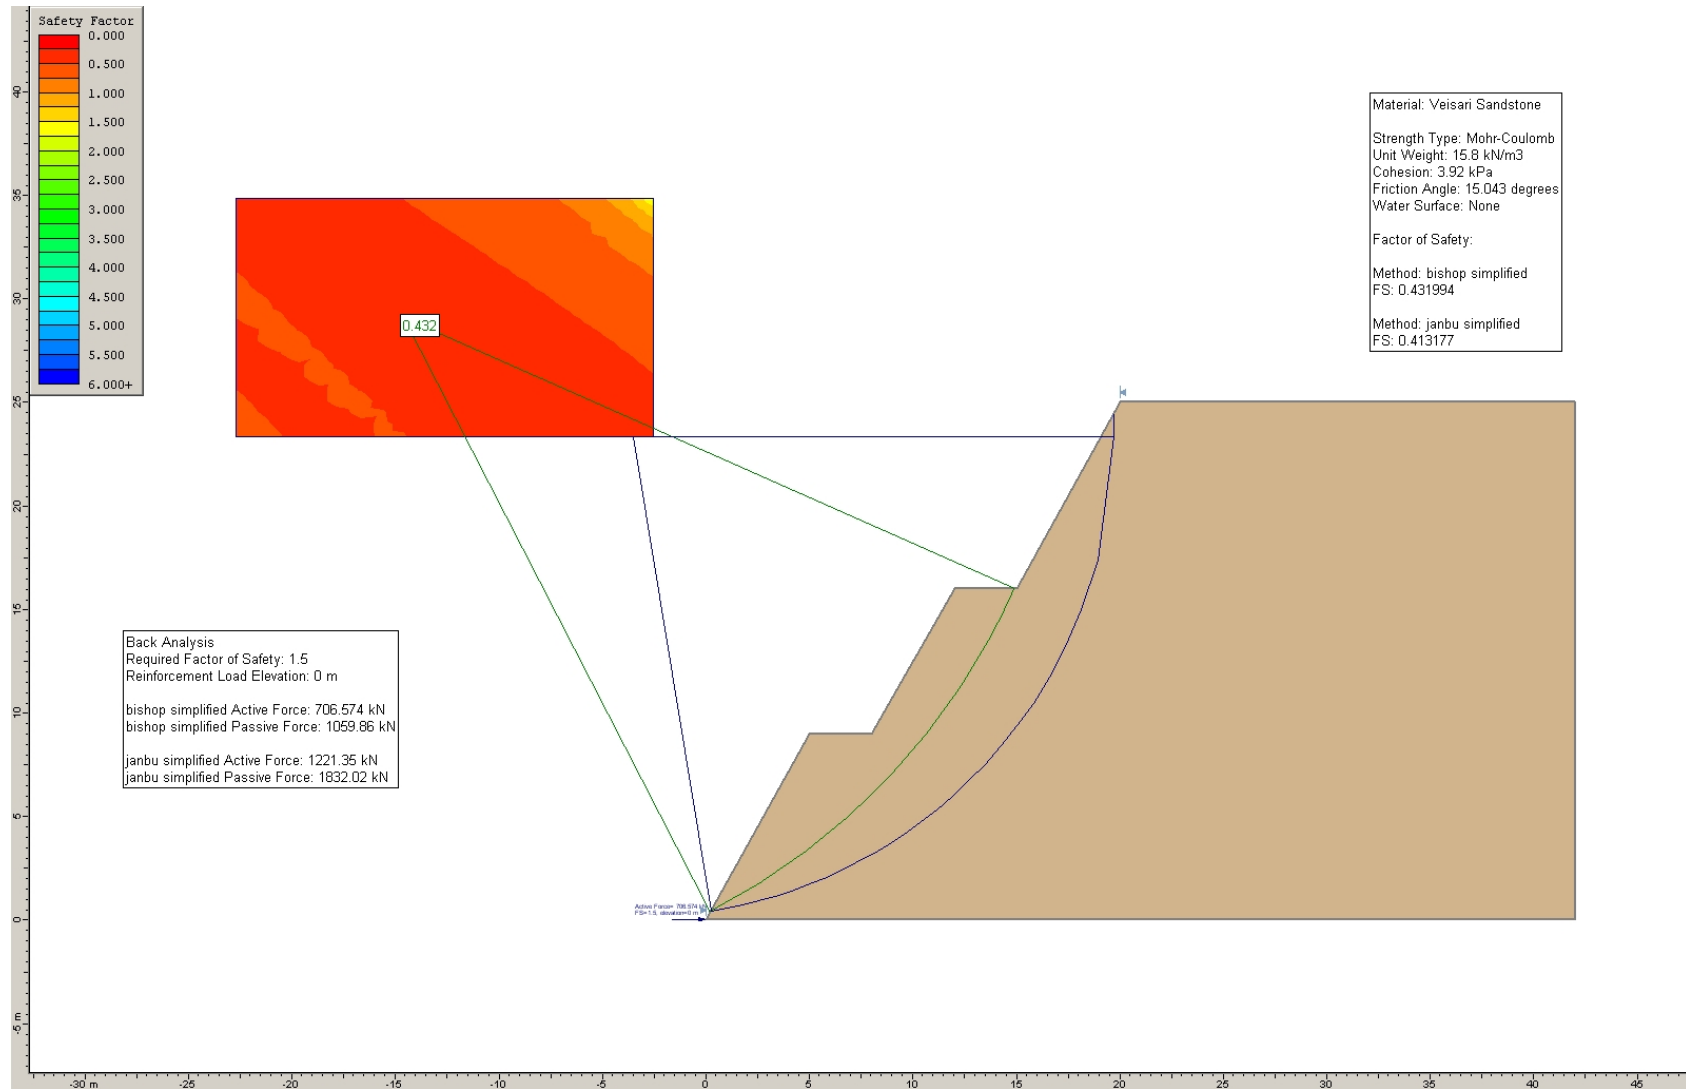
Figure 5.5 Back analysis using SLIDE for Wainigasau cut batters
